# Final DD Report

## RP7 Price Control Engineering Support & Asset Management Advice

Utility Regulator for Northern Ireland

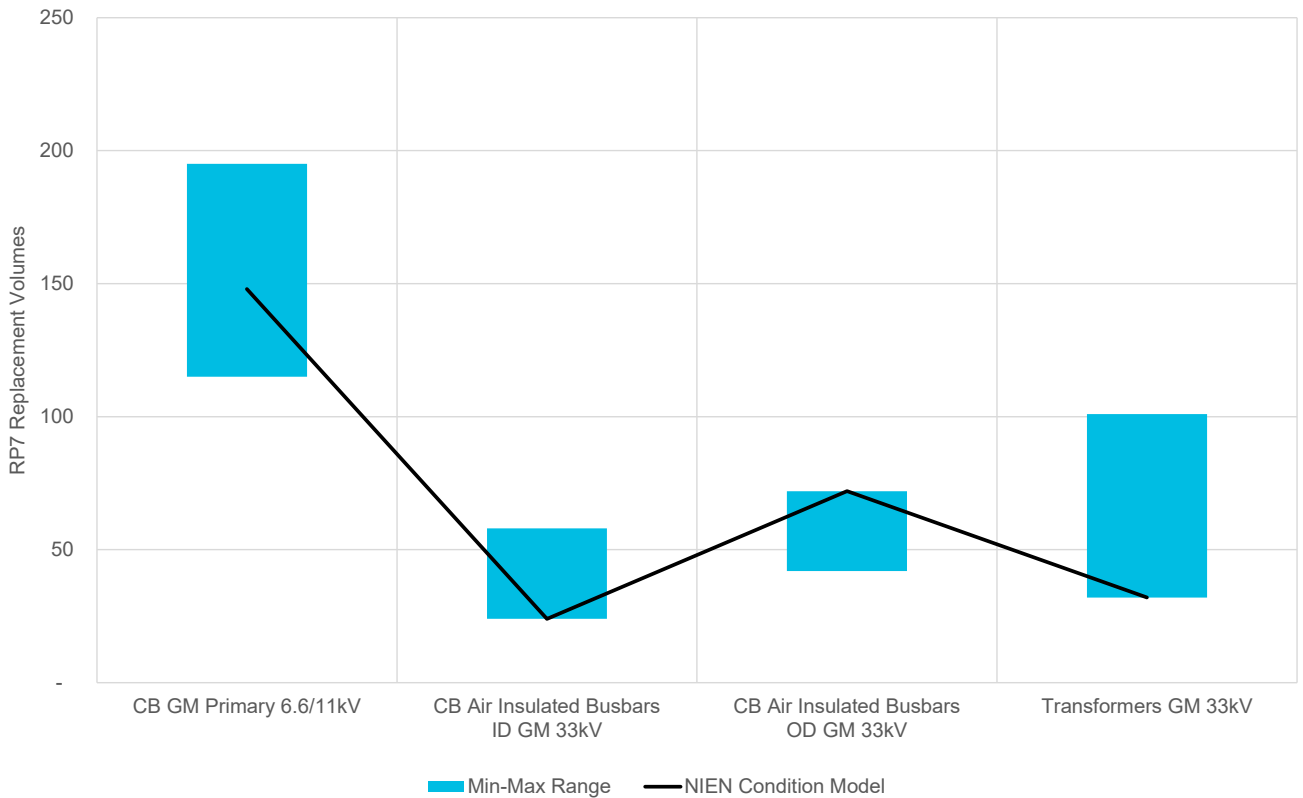
**Figure 2 Comparison of Model Outputs - 33kV Replacement Volumes**

In order to further verify the proposed RP7 replacement volumes, we also carried out a review of NIE Networks' replacement volumes from each of their modelling scenarios (described previously in Section 2.1.4). Figure 2 below shows the max-min range of the model outputs, in terms of RP7 for each of the three methodologies, with the NIE Networks condition-based model output also represented. It is evident that with the exception of the 33kV Outdoor CB asset category, the proposed replacement volumes are within range or the lowest of the model outputs.

For the 33kV Outdoor CB replacement volume, the NIE Network condition-based model produces the highest replacement volumes for RP7. This higher volume is driven by a specific type-defect (SWS EO1 type), described above for which NIE Networks has investigated repair options for the oil filled 33kV circuit breaker but with no viable solution being identified. We remain satisfied that the replacement volumes for these asset categories are reasonable for RP7.

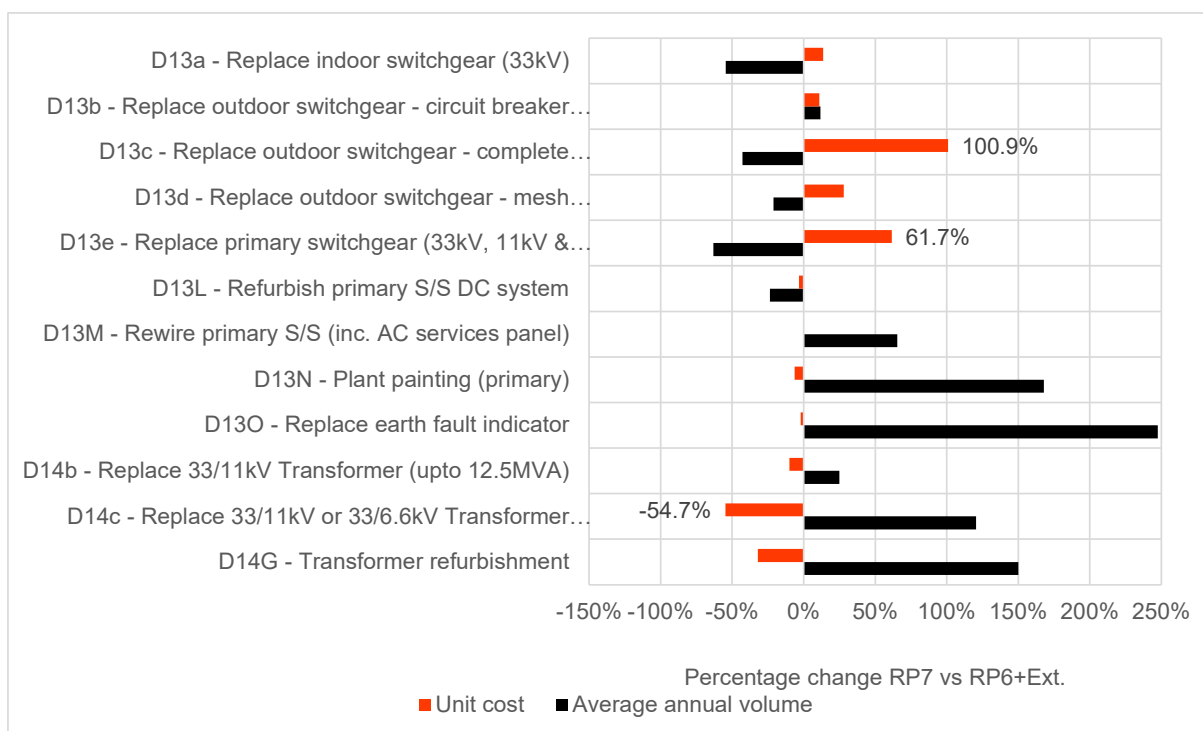
Figure 3 Distribution Primary plant – Unit cost assessment

The percentage changes in the unit cost (RP7 request compared with RP6 outturn to 31-Mar-2023) is presented in Figure 3, along with the equivalent percentage changes in asset volumes.

From Figure 3 it is evident that the requested unit costs for the D13c and D13e expenditure categories correspond to the greatest percentage changes. In addition, NIE Networks’ query response on unit costs<sup>12</sup> indicates the assessment carried out by NIE Networks to apply adjustments to the March 2022 outturn unit rates. These comprise adjustments to account for:

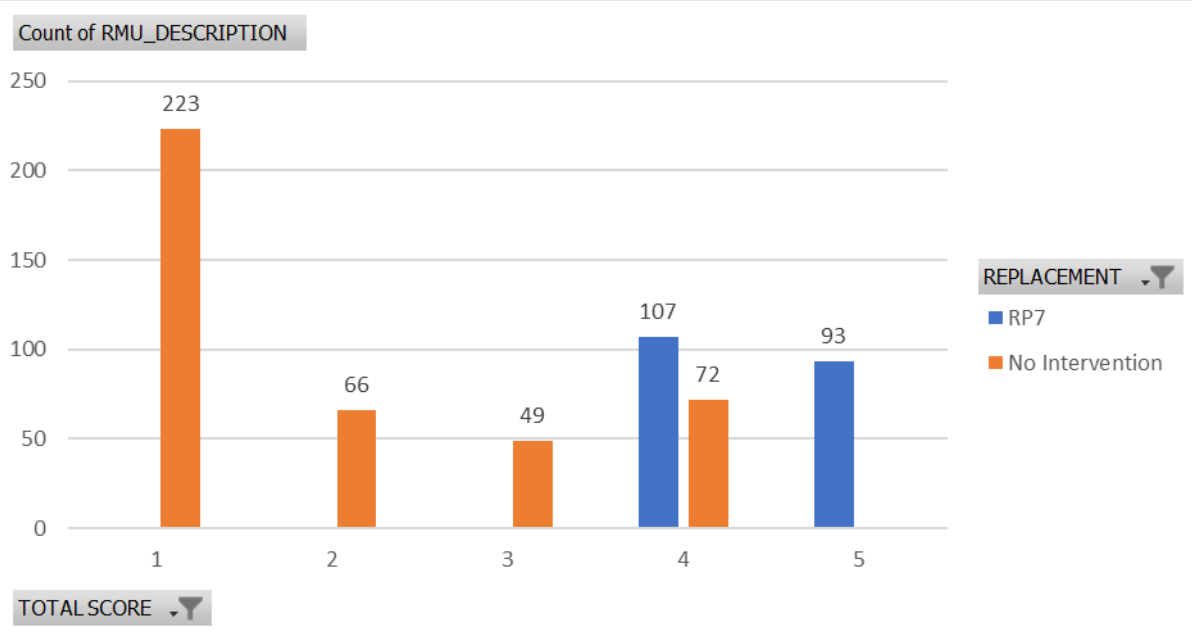
The figure below displays the breakdown of RMU only replacements proposed in RP7 against those with no planned intervention. It can be seen that those with higher total scores (which was made up only of the score attributed to “distance to coast”) have been identified for replacement ahead of others. In total, NIE Networks propose to replace approximately 33% of the total population of RMUs with the type defects in RP7 (however as noted previously the total population of RMUs with type defects is unclear based on the information that has been provided).

It was noted that there were 9 substations with the G.E.C. SATURN RT 11KV SF6 type RMU that had been included in both the D15a and D15b plans for intervention, indicating that they had been double counted in the volumes.

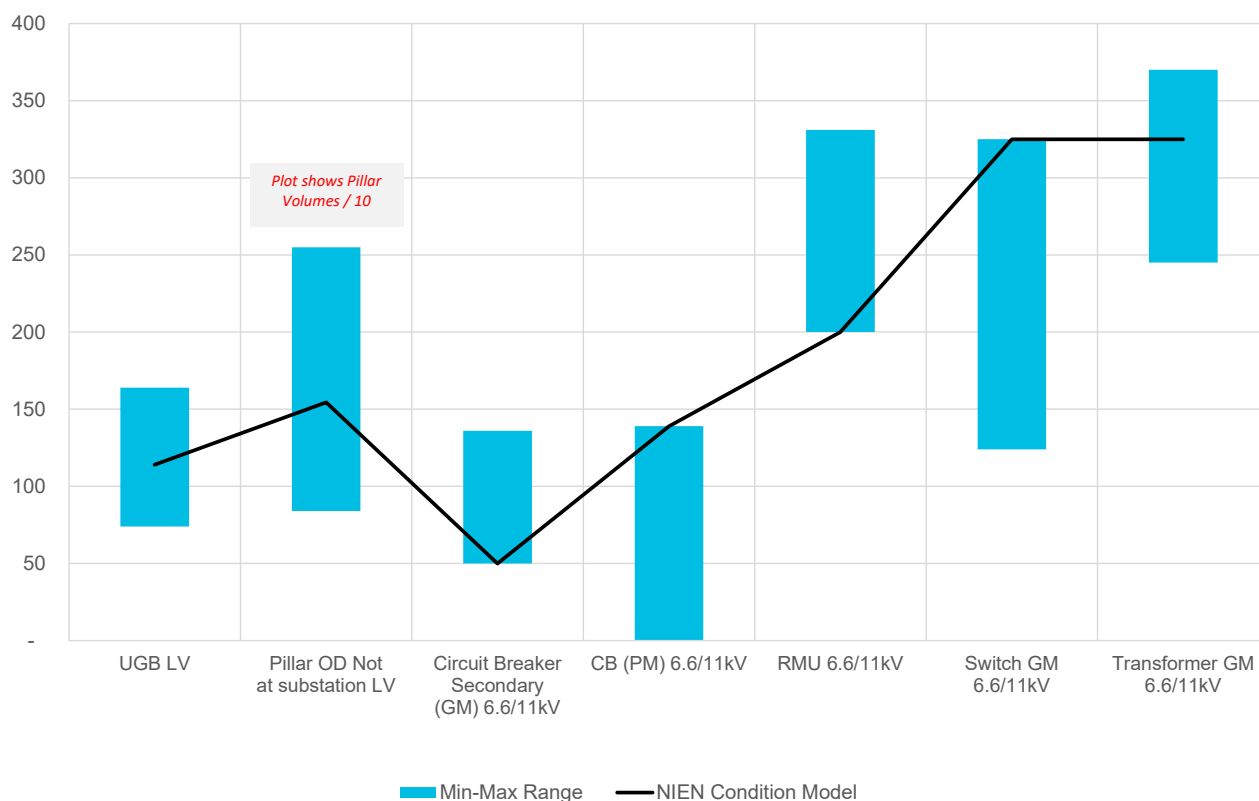
**Figure 4 Comparison of Model Outputs - 11kV & LV Asset Replacement Volumes**

In order to further verify the proposed RP7 replacement volumes, we also carried out a review of NIE Networks’ replacement volumes from each of their modelling scenarios (described previously in Section 2.1.4). Due to the sub-programme structure of NIE Networks’ Investment Plan, it is not possible to directly model replacement volumes for all asset types using all three methodologies. Where this is possible, either directly or indirectly (e.g. 11kV ground-mounted switchgear), we have included the asset type within our further review and Figure 4 below shows the max-min range of the model outputs, in terms of RP7 for each of the three methodologies, with the NIE Networks condition based model output also represented. It is evident that, with the exception of the pole mounted 11kV switchgear and ground mounted switchgear, the proposed replacement volumes are within range or the lowest of the model outputs.

For the 11kV ground-mounted switch replacement volumes, the replacement volumes are included within the work programme for complete substation replacement. The prioritisation of these replacement works is based on detailed condition-based assessment for the NIE Networks distribution substation portfolio, which the age-based survivor model would not factor into the calculation of replacement volumes. We remain satisfied that the replacement volumes for these asset categories are reasonable for RP7.

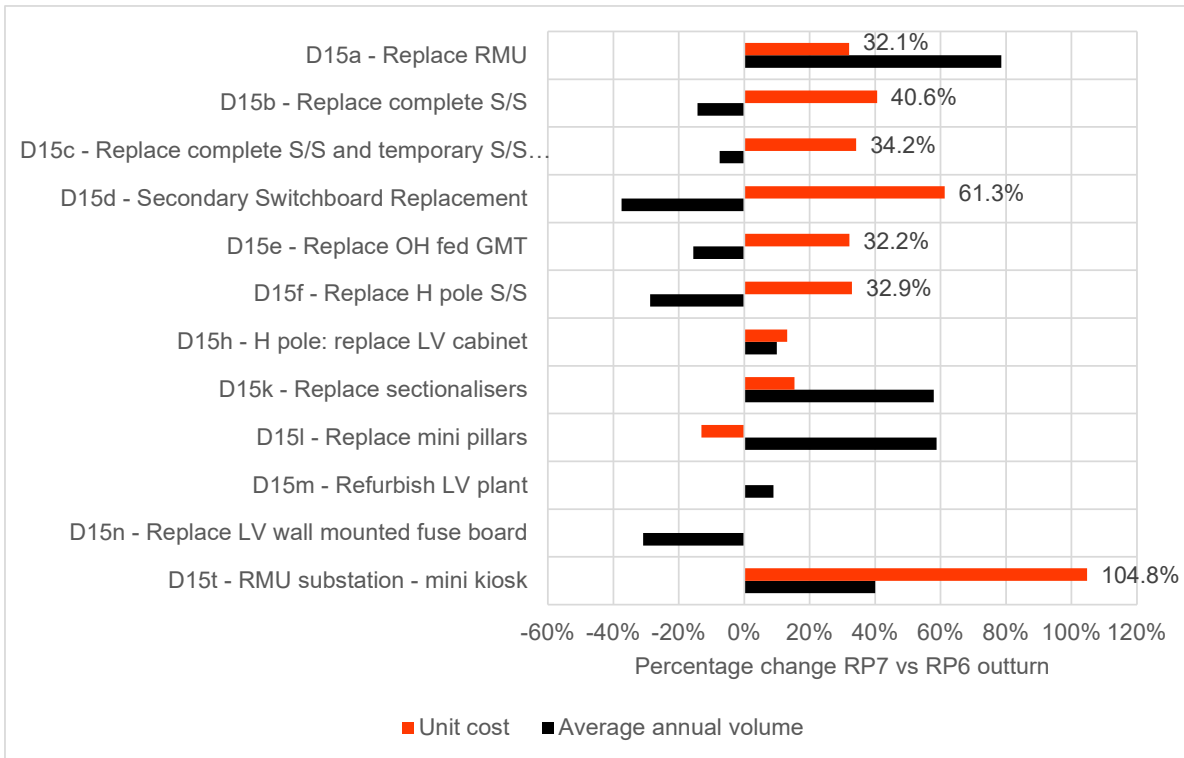
Figure 5 Distribution Secondary plant – Unit cost assessment

The percentage changes in the unit cost (RP7 request compared with RP6 Outturn) is presented in Figure 5, along with the equivalent percentage changes in asset volumes.

From Figure 5, it can be seen that 7 categories observed unit cost increases, when comparing RP6 outturn to RP7 that were greater than 20%, the largest increase being associated with RMU substation mini-kiosk replacements.

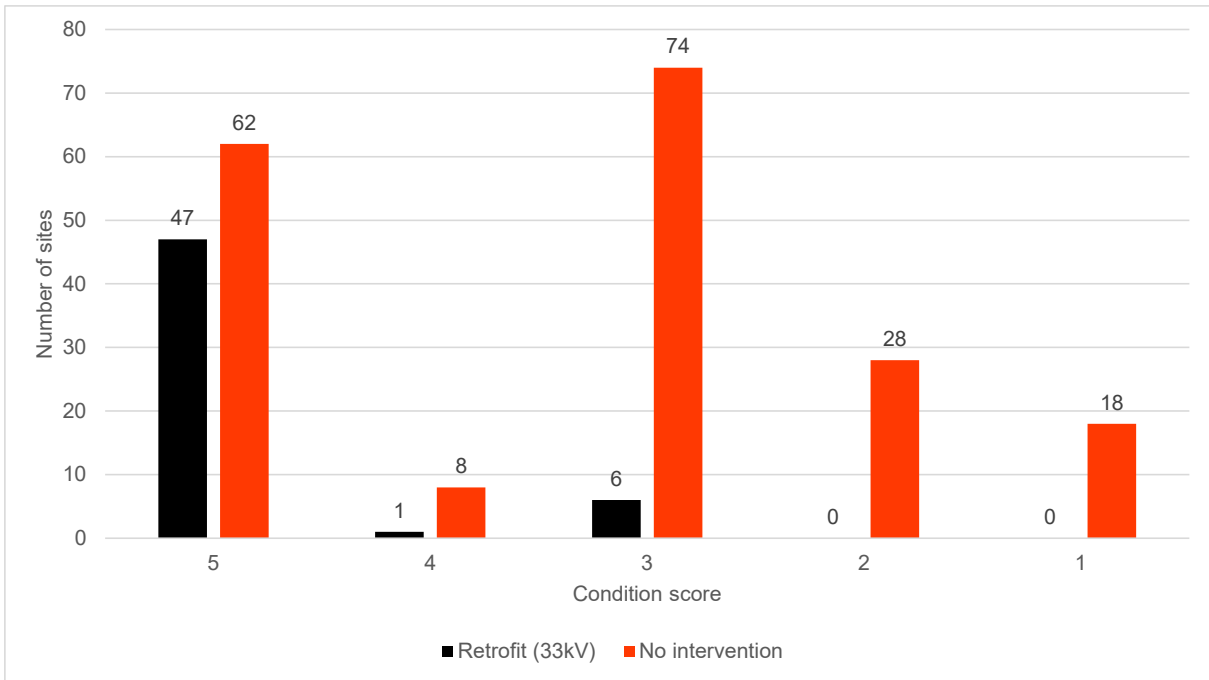
The following figures are taken from the response to query UR-091, which show only sites, but not the number of relays.

**Figure 6** Distribution protection – Condition assessment summary for 33kV sites (retrofit)

The results shown in Figure 6 and Figure 7 indicate a high population of sites where equipment has been assigned a score of 5 (immediate intervention required).

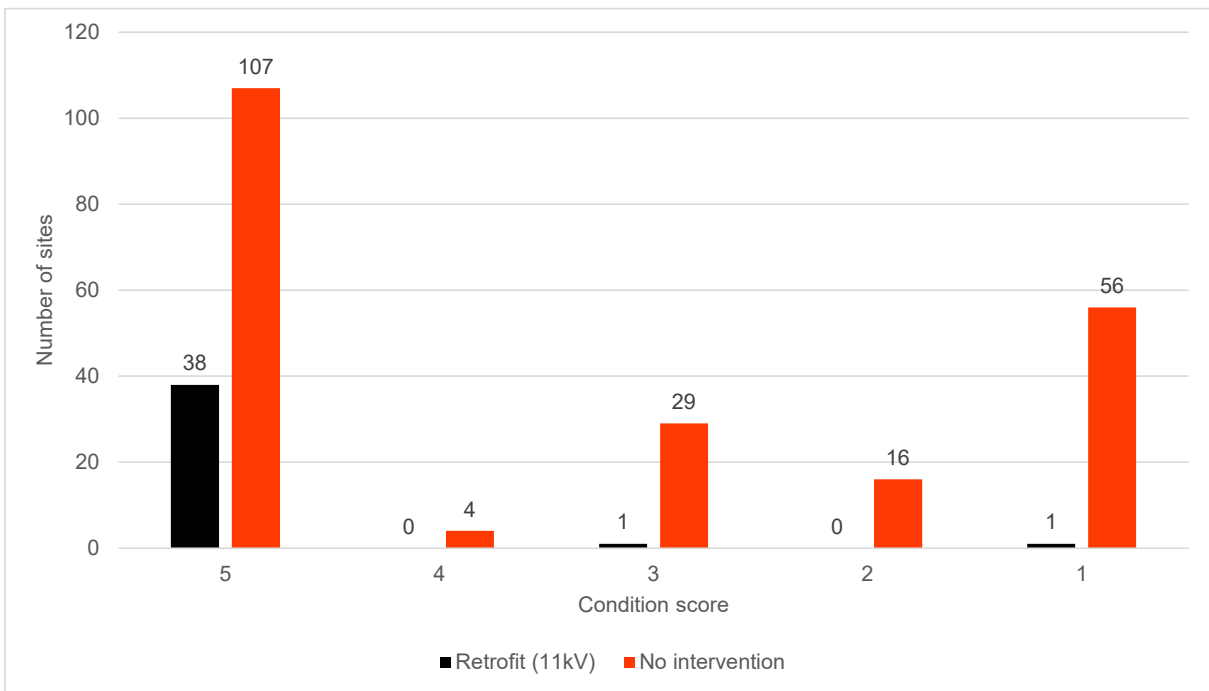
**Figure 7** Distribution protection – Condition assessment summary for 11kV sites (retrofit)
